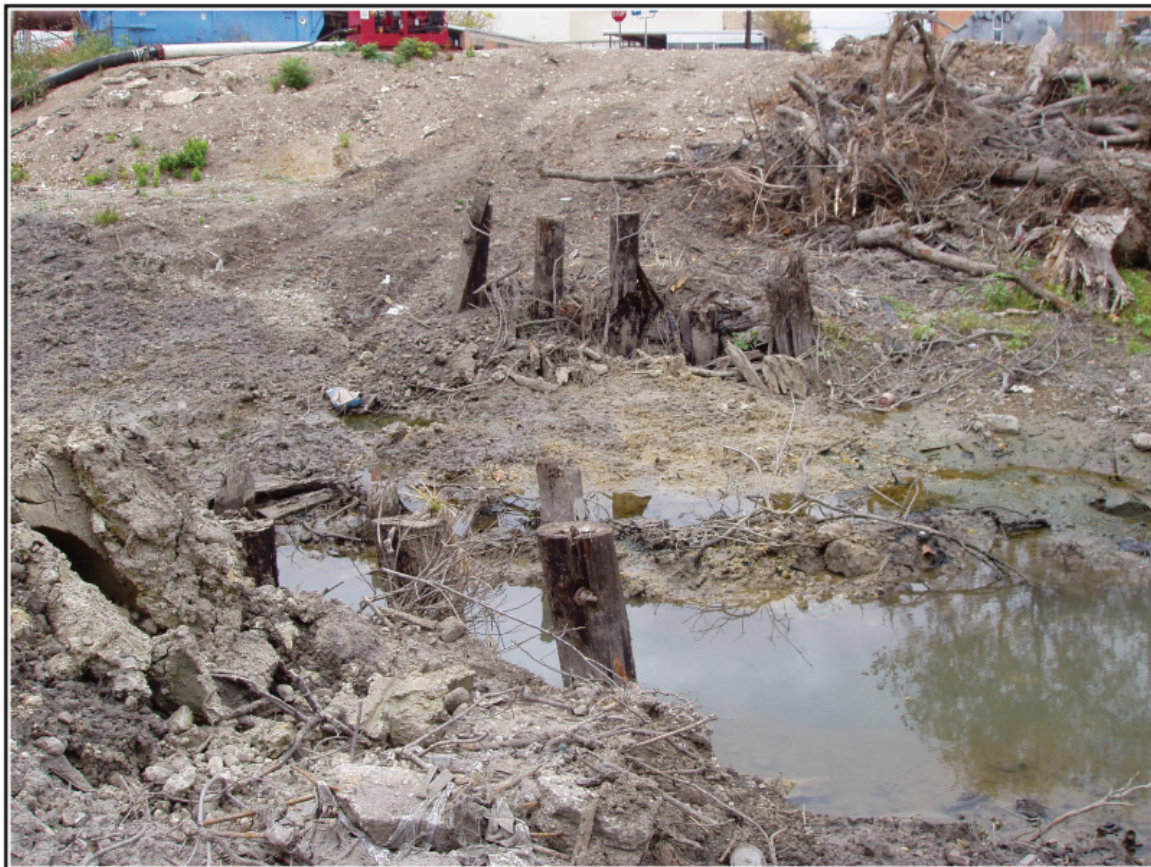
Figure 4-11. Railroad trusses located near Camden Avenue and Newell Street.

Feature 3 was located along the San Antonio River between the Camden Street Bridge and IH-35 (Figure 4-1). The feature consists of several railroad trusses in the east bank and the river channel. These would have been parts of a track that ran to the Pearl Brewery. Feature 3 was located during the initial reconnaissance of the Museum "Urban" Reach section of the San Antonio River Improvements Project (Antonia L. Figueroa et al. 2006). They were again noted during the monitoring of the construction of the Riverwalk expansion (Figure 4-11). Currently, no evidence of the trusses is visible in the river channel or along the bank. It appears the trusses were removed from the channel as to not be an impediment to the river barges. Landscaping of the east bank removed any signs of the wooden trusses.

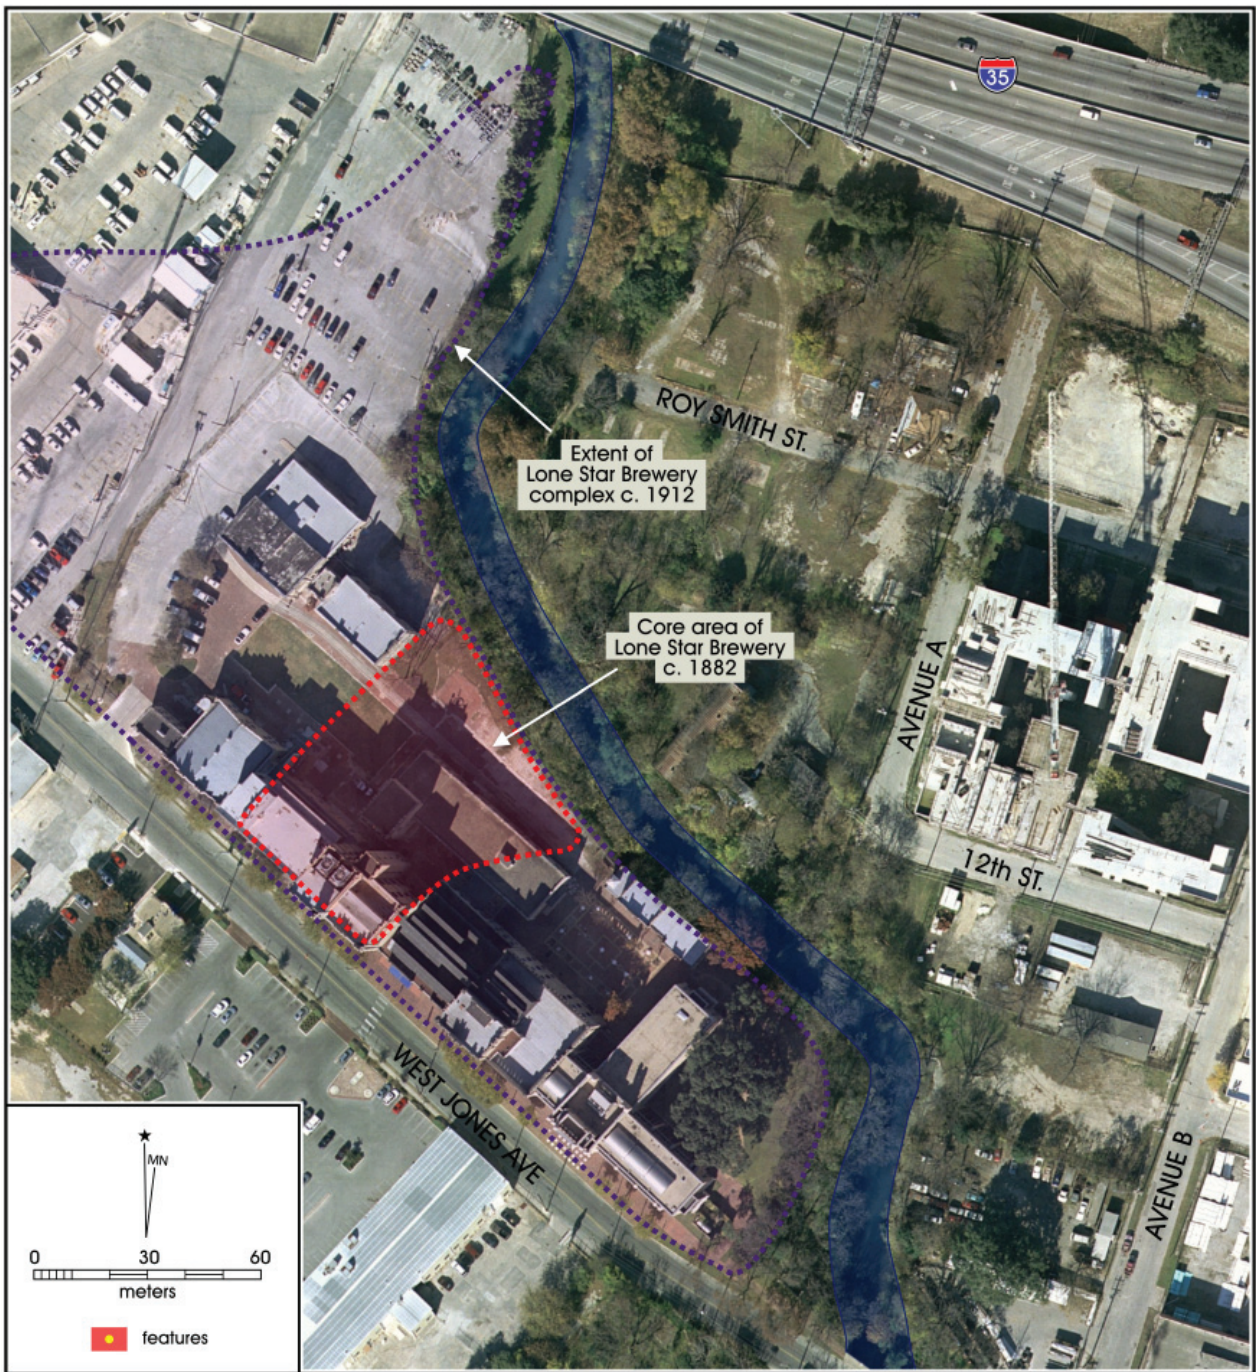
Figure 4-12. Aerial view of the features located adjacent to the Lone Star Brewing Company. Feature locations not shown.

Several features were located along the west bank of the San Antonio River north of Jones Avenue (Figure 4-12). These features are all within the vicinity of the San Antonio Museum of Art (SAMA), previously known as the Lone Star Brewing Company. After reviewing the location of the features, their proximity to SAMA, and the nature of the artifacts associated with the features it was deemed that these should be combined into one. All the features appear to have connection to the use of the Lone Star Brewing Company. The Brewing Company was founded by John H. Kampmann in 1884. It should be noted that this Lone Star Brewing Company should not be confused with the Lone Star Brewery, which produced Lone Star Beer, located near Mission Concepción. The company was in operation until 1892. Kampmann sold the business to Adolphus Busch and the complex was used to produce beer until 1918 when prohibition laws went into effect. Business continued, though the company produced soft drinks rather than beer. Busch promoted a soft drink called "Tango" that was supposed to make "palate dance with joy" during the Prohibition period (Jennings 1998). After production of the soft drink ceased, the complex was used for milling cotton (Jennings 1998). In 1925, the buildings were occupied by

Feature 4 was recorded just north of the Jones Street Bridge along the west bank (Figure 4-12). Down cutting of the bank uncovered a midden of glass bottles that had previously been covered by a concrete slab. The deposit of bottle was approximately 4 meters wide and two meters thick. The bottles noted in the deposit varied in colors, though the most common were aqua and olive (Figure 4-13). Makers marks noted on the bottles in the deposits included "Risches" and a triangle with an "R" inside. Many of the bottles retained their loop-wire closures. Within the glass deposit were metal straps that appear to have been from wooden kegs/casks. Fragments of cut bone and stoneware were also noted in the deposit. Just below the glass deposit appears a burned red

Northwest of Feature 4 is a brick wall located on the west bank of the San Antonio River (Figure 4-12). The wall is composed of bricks and cinderblocks (Figure 4-16). The upper portion of the wall is approximately 6 meter wide and contained Portland cement within the seams of the blocks. The cement served as a veneer to the stacked cinderblocks and bricks. Around the wall were historic trash deposits.

Feature 6 is a yellow brick "wall" that is located along the west bank of the San Antonio River just south of the IH-35 overpass (Figure 4-12 and Figure 4-17). The wall may be the outside of a cistern, though not round in form. The feature consisted of yellow bricks 21-x-10-x-6 cm in dimension laid to form a wall approximately 185 cm wide and 210 cm tall. Some fragments of bone and glass were found adjacent to the brick wall. The base of the feature exhibits stepped bricks, in which each course of brick is laid approximately 3 cm off center from the previous course (Figure 4-18). This occurs

Feature 7 is a lens of glass located along the west bank of the San Antonio north of Feature 5 (Figure 4-12). The feature was noted in the bank below one of the SAMA buildings located closest to the river. The feature consists of a fairly thick layer of broken aqua, clear, brown bottles (Figure 4-19). Several intact bottles appeared to have been present, though backhoe trenching broke most of the bottles. The concentration of bottles was approximately 70 cm thick, and spanned approximately 4 meters. A portion of the bottle concentration may remain in the river bank, though most was removed by the backhoe and grader. Currently, this area has been landscaped and appears to have a stairway leading to the new entrance of SAMA. The 1904 Sanborn's Fire Insurance Map notes that a well is located in the vicinity of Feature 7 (Figure 4-14). Further inland from the river bank

Feature 8 is another bottle dump located along the west bank of the San Antonio River. The feature is located south of Feature 6 and north of Feature 7 (Figure 4-12). The bottle dump appears to be approximately 1 meter thick and spans approximately 5 meters (Figure 4-20). Clear, brown/amber, and aqua bottles were deposited in this dump. Much of the dump consists of broken fragments of the bottles, though there were quite a few intact bottles. Unique specimen bottles of this dump were returned to the CAR laboratory to be added to the type collection. Many of the intact bottles are molded, with applied lips. The feature lay directly beneath the road base and asphalt that was used in the construction of the parking lot that was along the west bank of the river. According to the 1904 Sanborn's Fire Insurance Map, the feature is located within the vicinity of underground fuel and oil tanks (Figure 4-14). Also, it is located a few short distance to the south of the storage

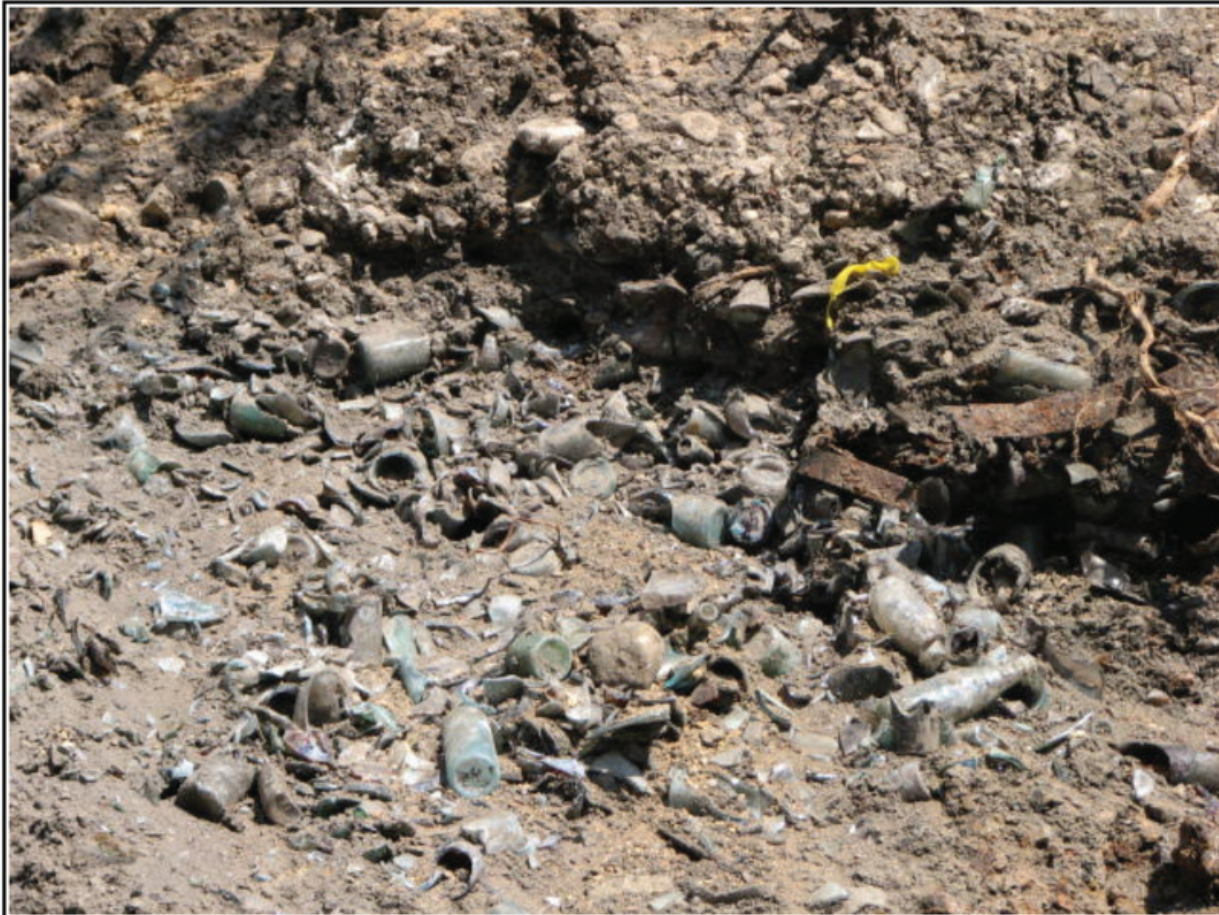
Figure 4-13. Glass bottles and fragments noted in Feature 3 (see Figures 4-1 and 4-12).

matrix that was 25 cm thick and extended 4.5 meters. The matrix is reminiscent of brick material. It did not appear to have any burned glass in this level.

The majority of the feature was removed during the construction phase of the expansion. A small portion of the deposit may remain buried under the current landscaping.

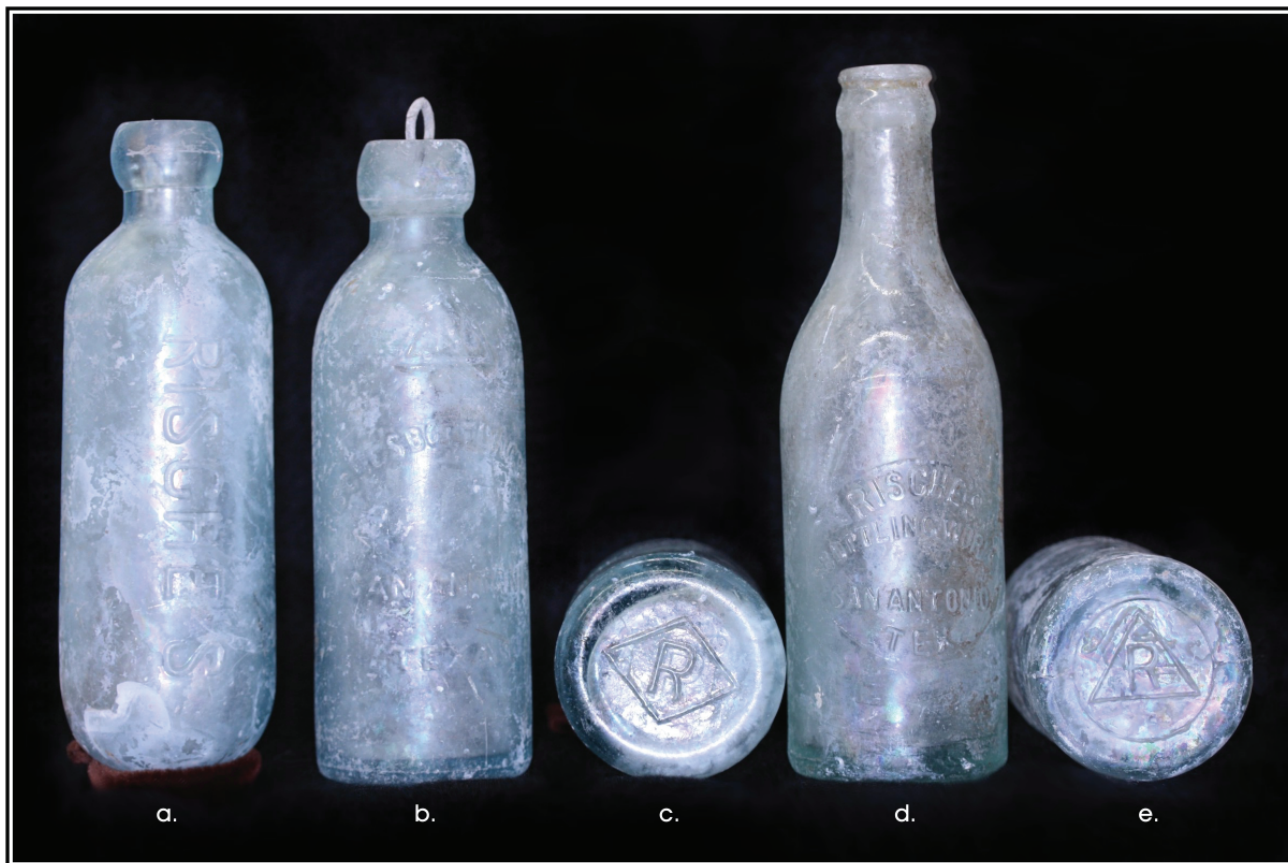
soda water bottles in the late nineteenth and early twentieth centuries. One (Figure 4-15a) is a round-bottomed bottle that had to be stored on its side. These bottles were designed not to be stood on the base so that the cork would not dry out and let the carbon dioxide gas out of the bottle (Lindsey 2009a). This bottle was made with an applied "blob" top, intended for a wired cork closure. It has the single word "Rische" embossed lengthwise on the body. There is no bottle maker's mark.

Another “blob” top Rische’s bottle was designed for a Hutchinson stopper and, indeed, that stopper is still in place (Figure 4-15b). The Hutchinson stopper, first patented in 1879, was such an improvement over previous closure types that it quickly became the standard for soda and beer bottle (Lindsey 2009c). The “blob” top is tooled suggesting a date after 1885 for the manufacture of the bottle. The bottle maker’s mark, an R in a triangle, appears three times, on the bottom and twice on the shoulder. This mark is that of the Reed Glass Company (Lockhart 2001), which operated between 1889 and 1927 (Mechow 2008). The bottle is also embossed “Risches Bottling Works/San Antonio/Texas”.

The other three bottles all have tooled crown cap closures (Figure 4-15 c and d). This type of closure, a variety of which is still used today on some soda and beer bottles, was patented in 1892 and became fairly common by the turn of the century (Lindsey 2009c). All three bottles were blown into molds and the crown finish tooled. Thus all probably date before 1910-1915, by which time almost all utility bottles were made on Owens machines. All three bottles have the same embossing: “Rische’s/Bottling Works/San

Antonio/Tx.”. Unlike the embossing on the bottles shown in Figure 4-15 a and b, the embossing on these bottles was done with a plate, though each plate was slightly different. This was a brass or iron metal plate that could be interchanged easily, allowing custom embossing of bottles in the same mold (Lindsey 2009b). Two of the bottles were blown in post-molds (see Figure 4-15 c and d), and have the Reed Glass Company’s R in a triangle mark on their bases. The bottle in Figure 4-15e was blown in a cup mold (see Lindsey 2009a), and has an R in a diamond maker’s mark that has not been identified (Figure 4-15d). It is tempting to assume this is another Reed mark, however, the R is not in the same font or style as those seen in the R in a triangle marks. Lindsey (2009a) has noted that most cup-mold soda and beer bottles probably date after 1900, and are more likely to be seen with crown cap finishes.

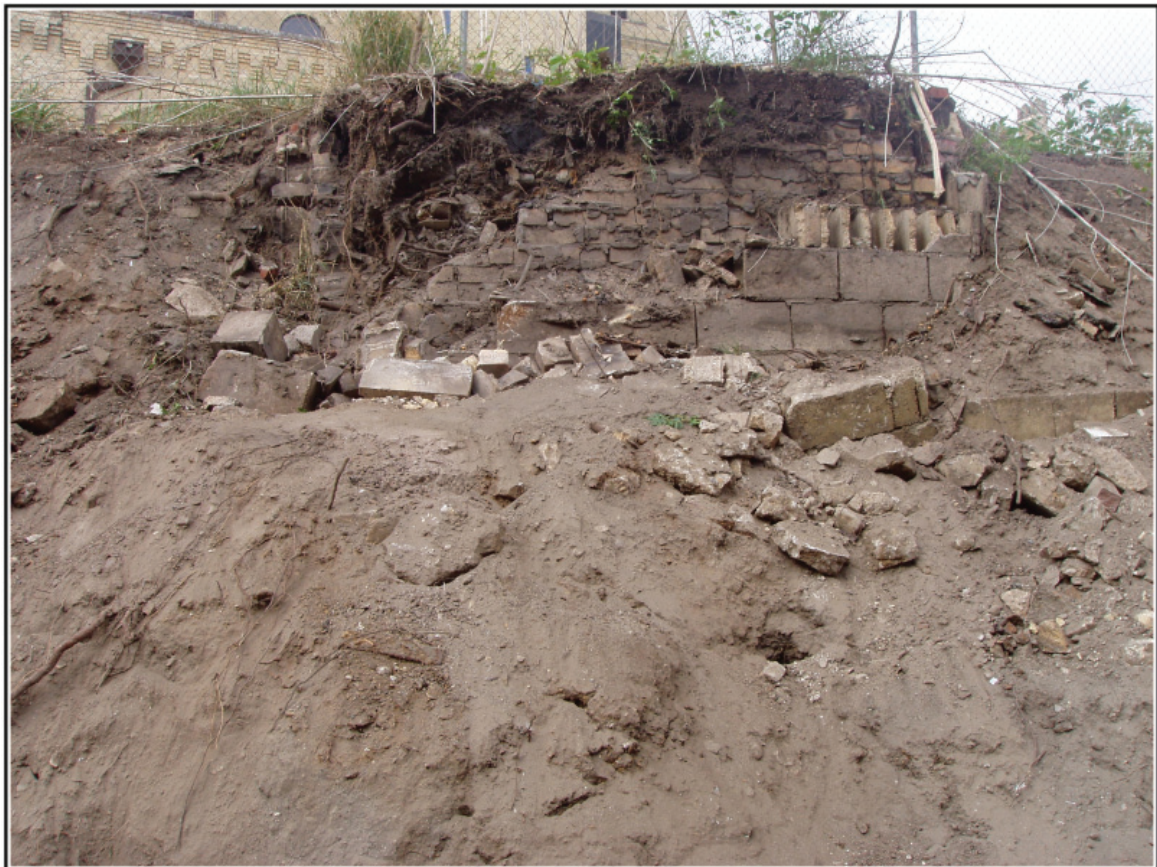
Figure 4-16. Feature 5, brick wall (see Figures 4-1 and 4-12).

Aqua and amber glass bottles and fragments were noted in the deposit. Other artifacts noted include horseshoes, undecorated white earthenware fragments, and a metal spike. The feature was located near the building labeled on the 1904 Sanborn's Fire Insurance Map as the Wash Shed and Cooper/Carpenter Shop (Figure 4-14).

A portion of this feature may remain in the banks of the river, though the majority was removed to make way for the retaining wall and landscaping of the Riverwalk expansion.

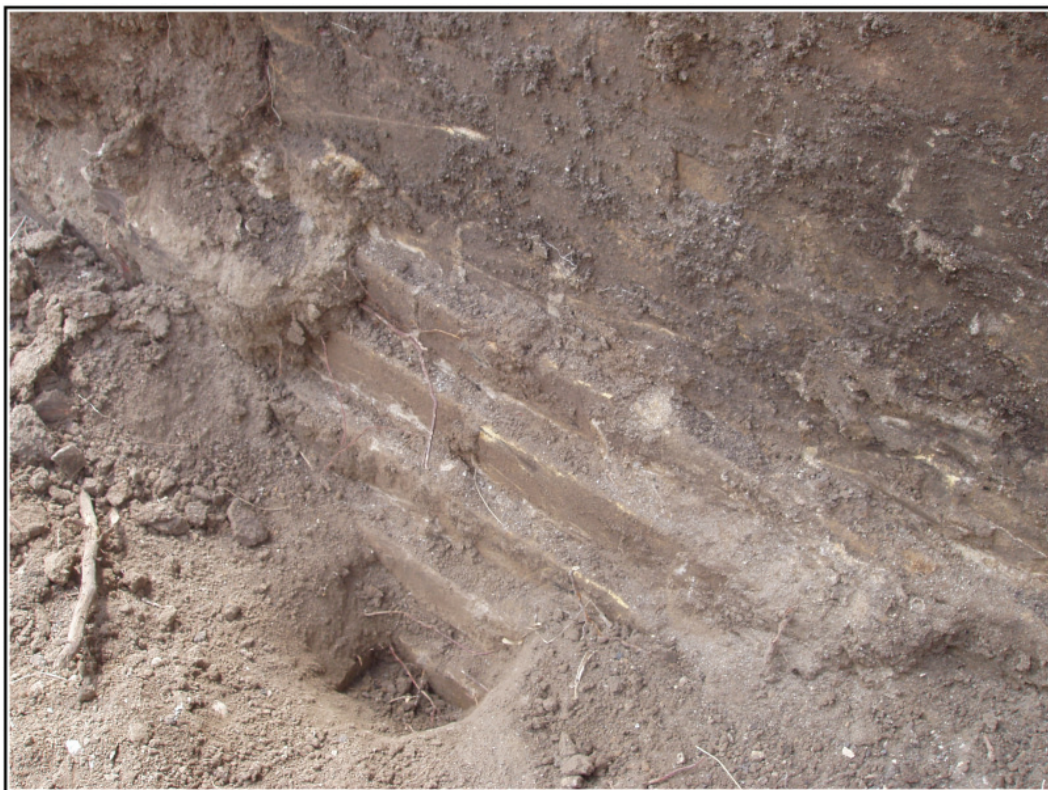
Figure 4-18. Base of Feature 6 noting the stepped bricks.

for at least six courses of brick. The feature may remain in the bank of the San Antonio River, covered with a concrete retaining wall and landscaping. A structure was not noted in the vicinity of the feature on the 1904 Sanborn's Fire Insurance Map, but a storage area was noted in that location on the 1924 map.

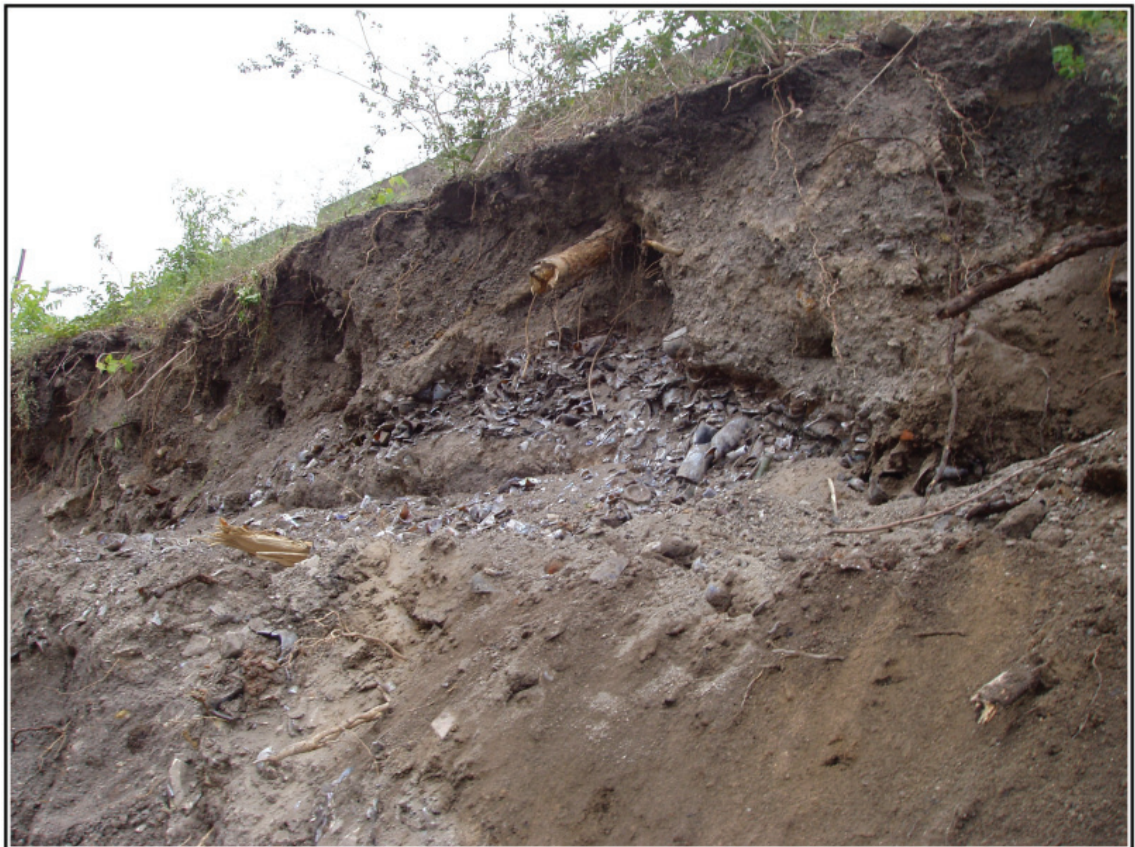
Figure 4-19. Feature 7, bottle dump (see Figures 4-1 and 4-12).

in the vicinity of Feature 7 was also a Bottle Storage facility in 1904 (Figure 4-14). It is possible that unused bottles, or bottles needed to be disposed of during Prohibition, were discarded behind the facility, along the river bank.

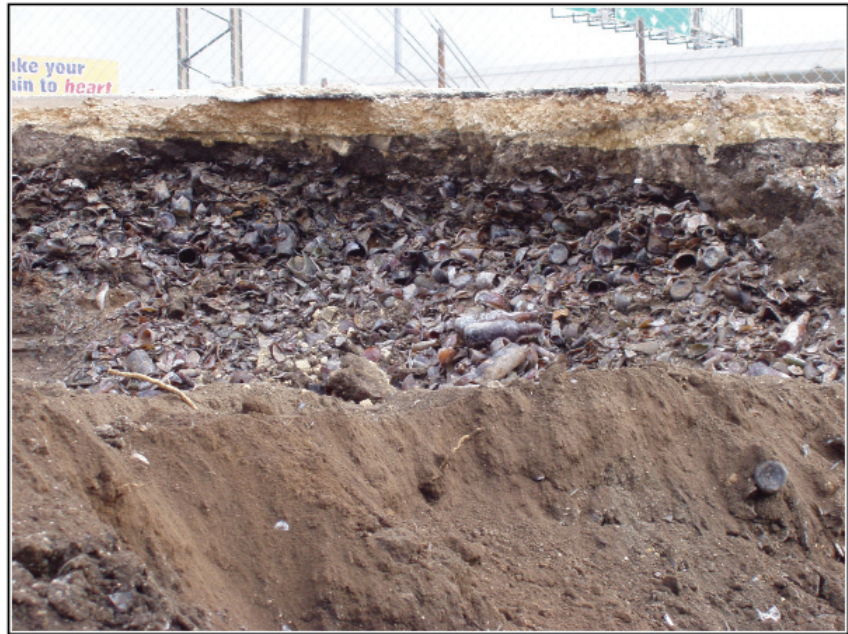
Figure 4-20. Feature 8, glass bottle deposit (see Figures 4-1 and 4-12).

area that appears on the 1924 map. It is possible that the bottle are related to the later storage facility, and were discarded along the bank of the river.

A portion of the feature was removed during the Riverwalk expansion, though it appears that some remained under the parking lot. Currently, a concrete retaining wall was constructed and the upper portion has been landscaped. The parking lot remains adjacent to the river.

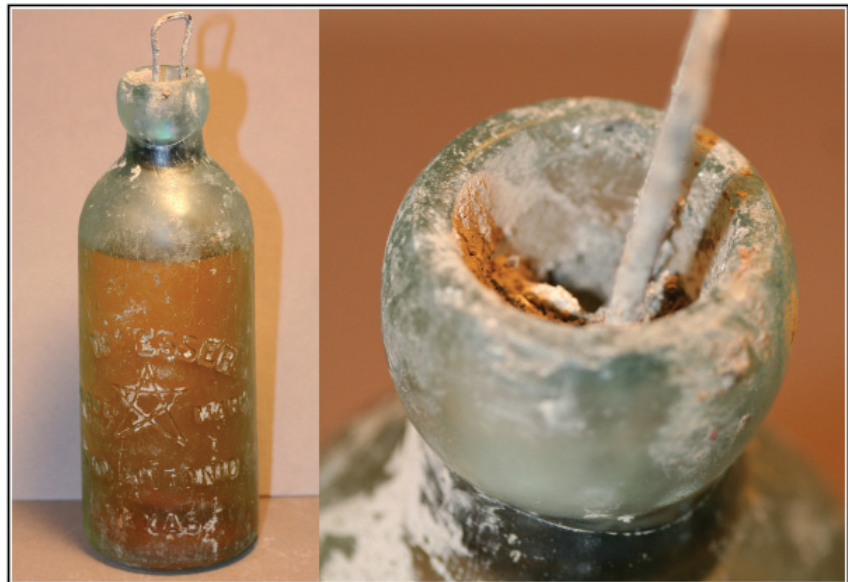
Figure 4-21. Esser bottle recovered from behind the Lone Star Brewing Company complex on the west bank of the San Antonio River.

These features all appear to have connections to the use of the Lone Star Brewing Company. The bottles encountered in the deposits are consistent with the use of the complex during the years that the brewery was functioning. One bottle collected was curated at the Center for Archaeological Research laboratory. When encountered, the bottle retained its sealed stopper and contents (Figure 4-21). The bottle was brought to the lab, and the contents were removed prior to curation.

The bottle was about 4/5ths full of yellow liquid. A small amount of dark brown sediment was at the bottom of the bottle. When opened, there was a distinct smell of yeast and vinegar. The ph level of the liquid was recorded as 4. The UTSA Safety Office tested for bacteriological and organics and found that the liquid was not hazardous. Three samples were saved by CAR for further testing opportunities, including the sediment. The bottle had the name William Esser embossed on its surface. William Esser was a brewer and had purchased the property today known as the San Antonio Museum of Art. He owned and operated the brewery from 1875 until it was purchased by Adolphus Busch in 1884 (Hennech and Etienne-Gray Tx Handbook online). Esser remained as the proprietor of the Lone Star Brewing Company until 1891. The type of closure on the bottle used is the Hutchinson Spring Stopper (Figure 4-21). The stopper was patented in 1879 and was very quickly adopted as the preferred method of closing soda and beer bottles. Due to the time period that Esser owned the brewery, and the type of stopper used, the beer and bottle were likely manufactured between 1879 and 1884.

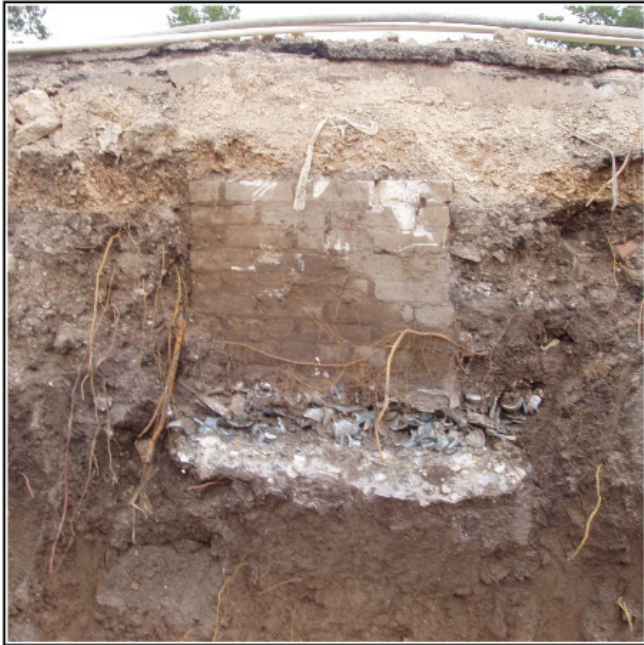
Figure 4-22. Feature 9, a brick wall with glass at the base (see Figure 4-1).

Feature 9 is a yellow brick wall similar to Feature 6 that has a lens of glass at its base (Figure 4-22). The Feature was noted in the east bank of the San Antonio River, approximately 200 feet north of the Brooklyn Street Bridge. The top of the feature was noted approximately 50 cm below the surface of the bank. The yellow brick wall was approximately 90 cm in height, and 80 cm in width. Just below the brick wall was

a layer of aqua glass fragments and partially intact bottles. The glass appeared to have been dumped into wet cement at the time of construction. No intact bottles were able to be removed due to the fact that they were encased in the cement. The layer of cement and aqua glass was approximately 30 cm in thickness below the wall.

It is unknown if a portion of the feature is present in the current bank of the river. The location of the feature is now where the lock-dam system has been constructed for the river barges. The feature was documented, most likely removed due to the extensive nature of the amount of soil removed in the immediate area.

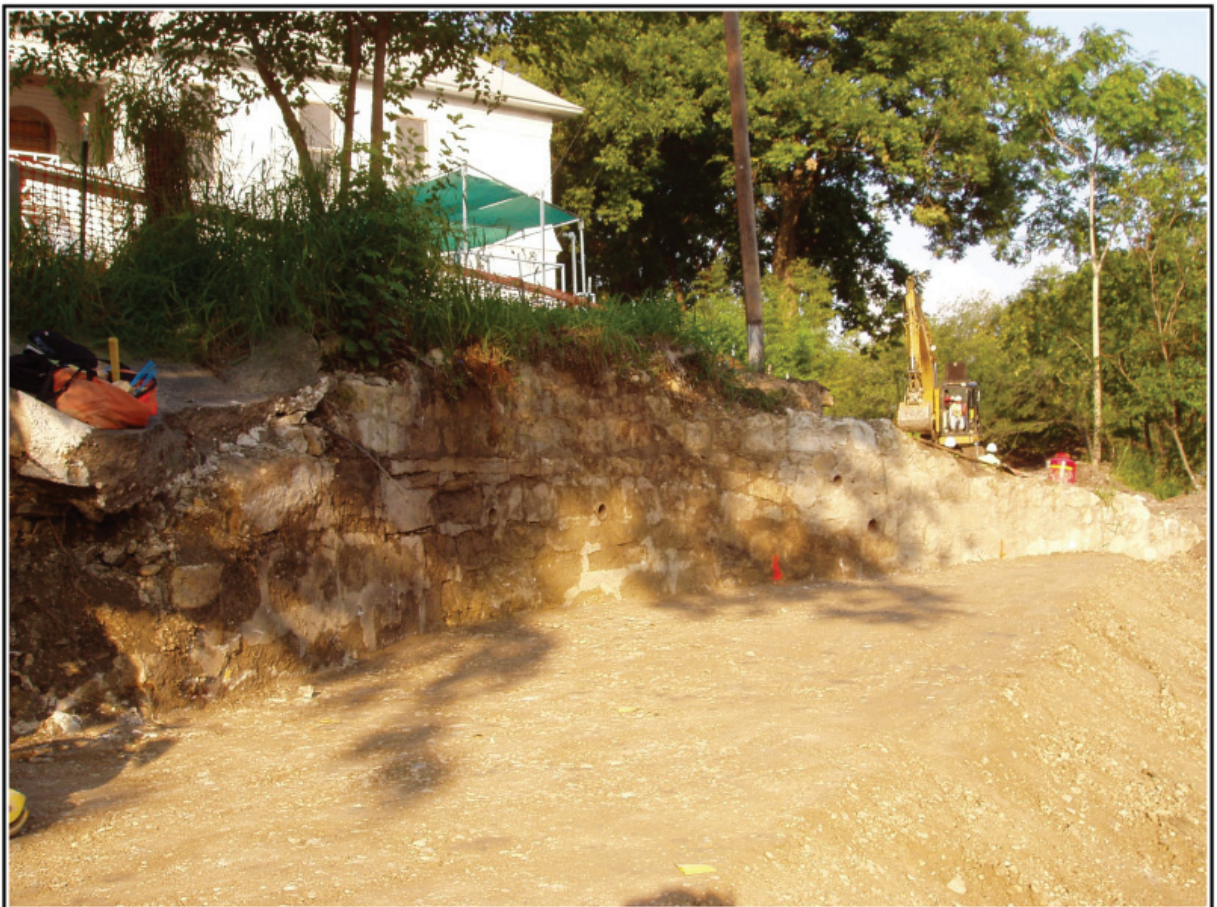
Figure 4-23. Feature 10, the stone wall located near the VFW Post #76 (see Figure 4-1).

Feature 10 a stone wall that was uncovered adjacent to the VFW Post #76, just south of the Alamo Mills Dam. This feature was located on the east bank of the San Antonio River. The stone wall was constructed of cut limestone and mortar (Figure 4-23). The stone wall was approximately 15 meters in length, and 50cm thick. Backhoe excavations

around the wall revealed one stone in the wall that exhibited the initials "P.F." and a date of 1909 (Figure 4-24). Several openings were noted that at one time allowed drainage pipes to empty into the river, though the amount of sediment that had accumulated prevented that in recent years. The stone wall could not be incorporated into the architecture of the Riverwalk like the Alamo Mills Dam. And due to the more recent age of the wall, it did not meet the qualifications of further investigations or preservation. The stone wall was documented and removed to allow for the construction along the Riverwalk to occur.
